# Rivers Tame and Trent Strategic Resource Options Aquatic Ecology Monitoring

Final Report

Affinity Water, Anglian Water Services Ltd and Severn  
Trent Water Ltd

Project reference: C-03798  
Project number: 60662976  
REP-001\_D22

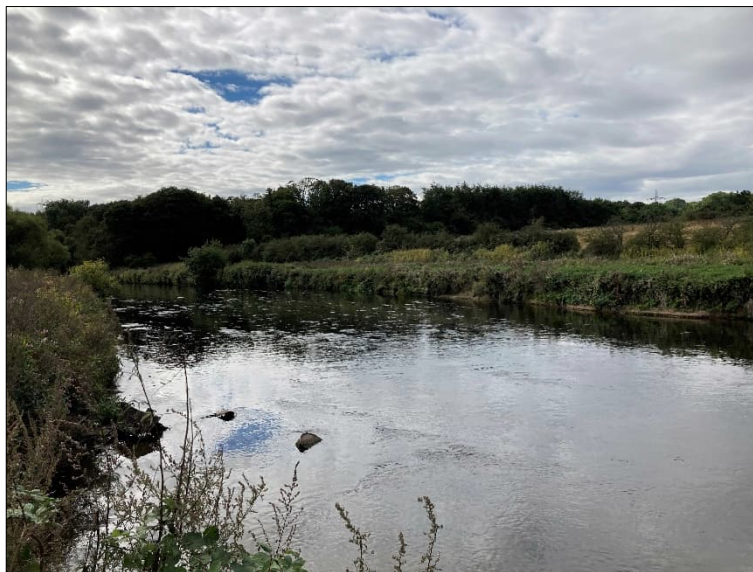
**Figure 1: River Tame general structure with urban trash in channel**

smooth with unbroken standing waves at riffles and marginal dead water. The channel was reinforced at the downstream end in association with the bridge crossing. Urban trash was present in the channel.

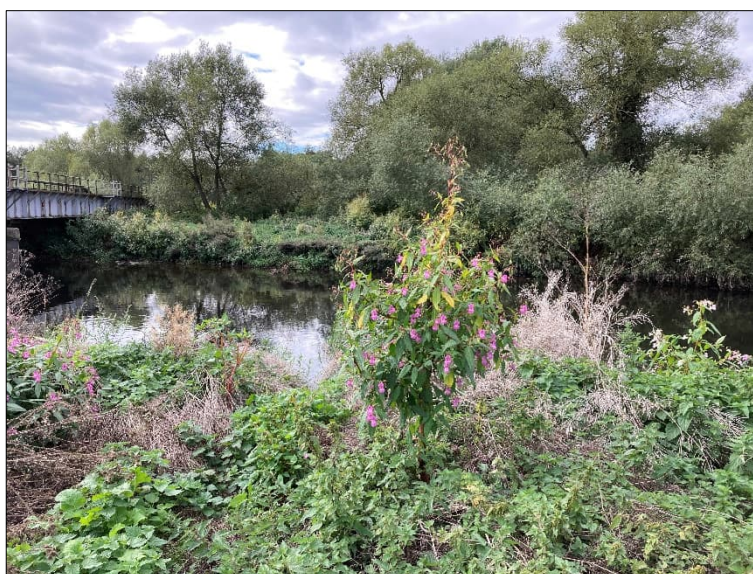
**Figure 2: River Tame downstream of rail crossing with extensive Himalayan balsam on bank top**

- 3.2.119 The River Tame in this location was assessed as Severely Modified (HMC = 5) with major impacts identified as rail, road and realignment. River habitat quality was assessed as Poor (River Habitat Quality class = 4) with a management objective to Rehabilitate. The site was considered to be at very low risk of impacts from agricultural sediment load. INNS were extensive on both banks in the form of Himalayan balsam with greater than 33% cover on both the bank top and bank face (Figure 2). Giant hogweed *Heracleum mantegazzianum* was also present on the right bank top.

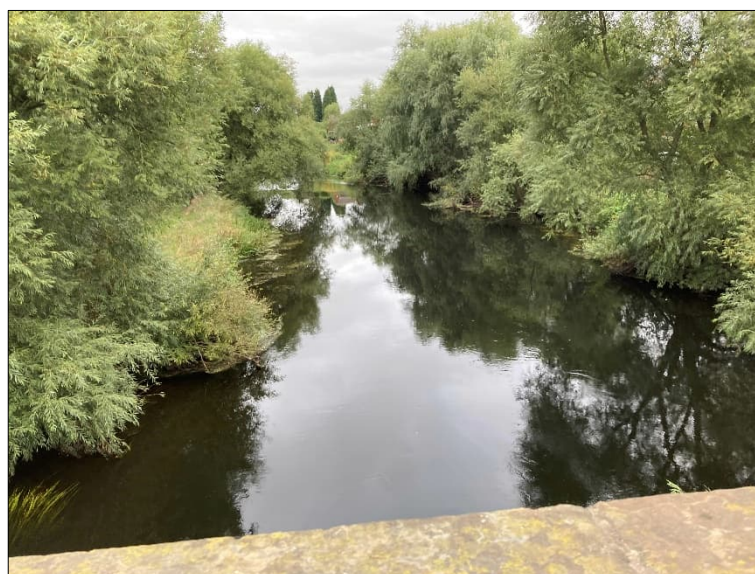
**Figure 3: River Tame looking downstream from Watling Street**

- 3.2.123 Land use was generally improved grassland and plantation broadleaved woodland extensive on the left bank, with tall ruderal vegetation and suburban development dominant on the right bank in the form of the Tamworth suburbs. Bank vegetation structure was generally simple with riparian trees on the right bank leading to complex structure, with channel shading, overhanging boughs and woody debris increasing channel diversity (Figure 3). Emergent broad and linear-leaved macrophytes were present, together with submerged macrophytes and filamentous algae.

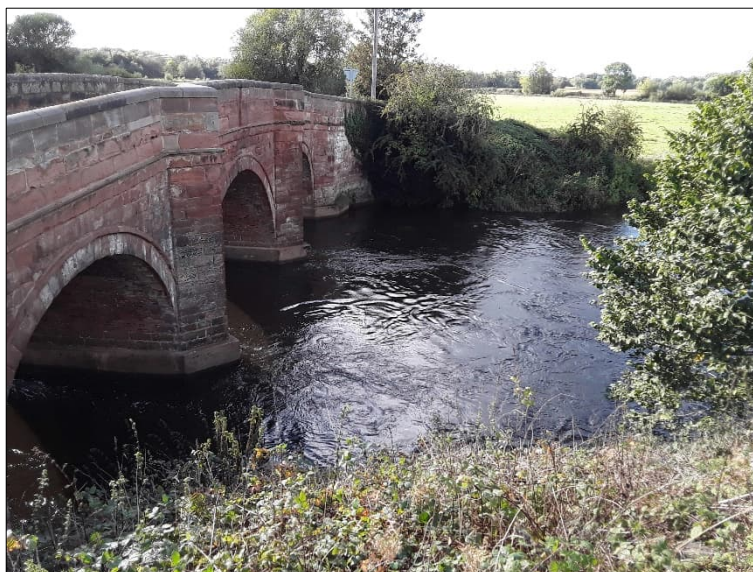
**Figure 4: Elford Bridge at upstream end of TA5**

- 3.2.125 The River Tame was surveyed at Elford downstream of Elford Bridge (Figure 4). Adverse conditions somewhat constrained the survey due to the presence of dense, steep overgrown banks and access constraints; however, the survey was completed satisfactorily. The bed of the river was only partially visible due to turbidity of the water. The river sat in an asymmetrical floodplain with low-lying arable land on the left bank and a steep-sided wooded bank on the right up to Burton Road, The Shrubbery, and the village of Elford. The left bank was approximately 1.5 m in height, the right bank much higher at about 6 m, water width 35 m and bank full width 40 m.

- 3.2.126 The channel was uniformly deep and steep sided with no riffles present, a single major bridge at the upstream end (Elford Bridge), and three minor outfalls for road and surface water drainage. The channel was not obviously realigned with historic maps showing its course has remained unchanged for the recorded period, but the right bank was heavily reinforced to stabilise the bank below the roads and village.

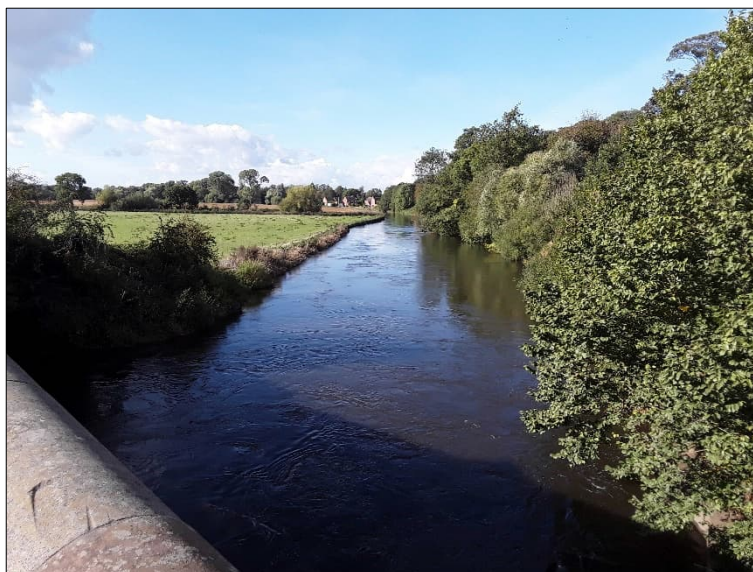
**Figure 5: River Tame TA5, general character**

- 3.2.130 The River Tame in this location (Figure 5) was assessed as obviously modified (HMC = 3), with the river habitat quality class of 3 indicating moderate habitat quality with a management objective of enhance. Fine sediment accumulation was considered low; however, some agricultural impacts were considered likely from land use on the left bank and impacts from suburban drainage and runoff on the right bank.

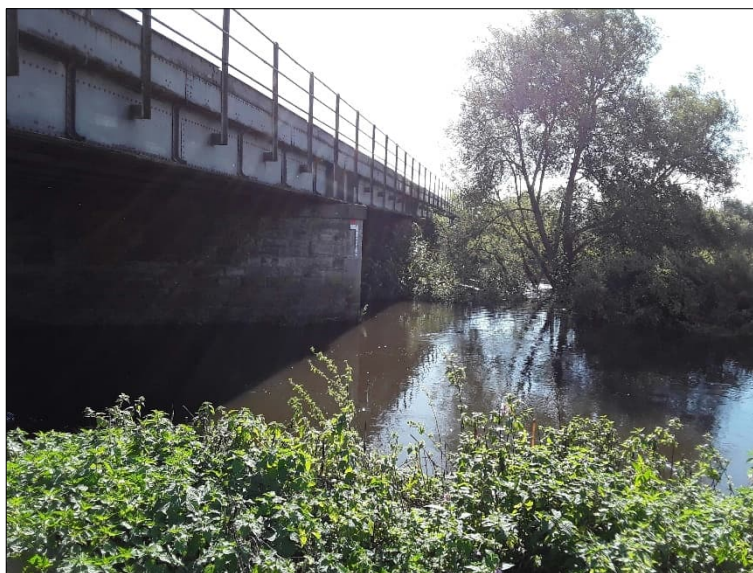
**Figure 6: Wichnor rail viaduct at downstream extent of TA6**

3.2.132 A single minor outfall was recorded in the form of a drainage channel from the arboretum. No riffles or point bars were present. The channel was divided by a large mature island for the downstream half of the survey extent. Vegetated mid-channel bars were also present. No bridges were present in the survey reach; however, the Wichnor viaduct constituted a major bridge immediately downstream.

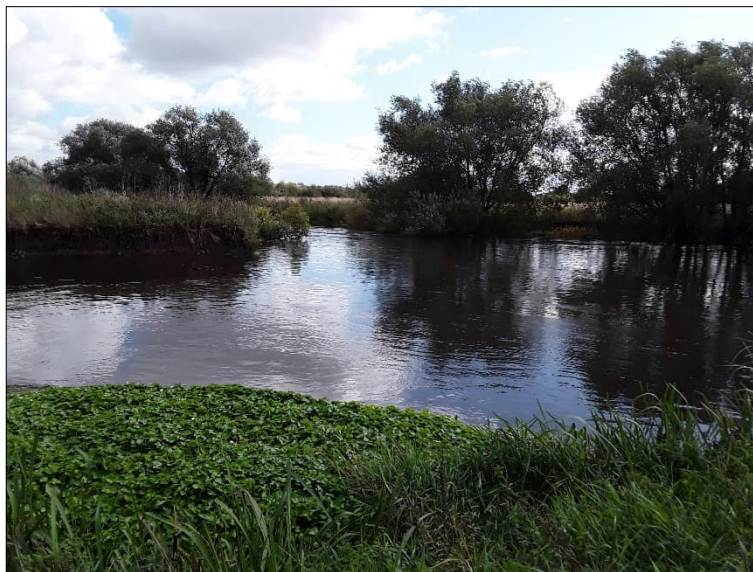
**Figure 7: River Tame TA6 general character; floating pennywort in foreground**

- 3.2.135 The river at this location was approximately 40 m in width, with a bank full width of 45 m. Bank top heights were consistently 1.5 m, with water depth estimated at 2 m.
- 3.2.136 The INNS Himalayan balsam and floating pennywort *Hydrocotyle ranunculoides* (Figure 7) were present along the left bank. Kingfisher was observed, and there was suitable nesting habitat for this species, especially on the right bank.

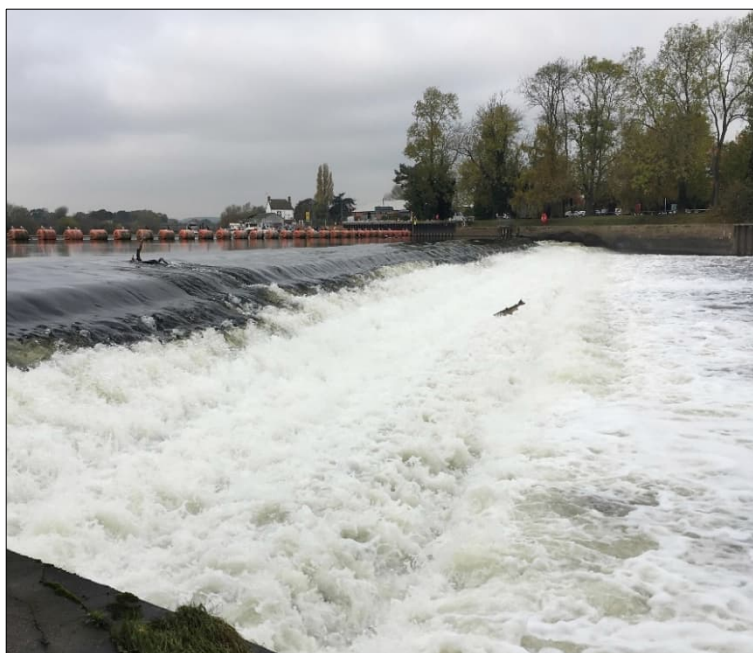
**Figure 8: Salmonid attempting to pass Gunthorpe weir (11/11/21)**

- 3.5.5 Salmon were observed jumping the weirs at Gunthorpe and Stoke Bardolph on 11 November 2021 by AECOM hydroecologists (Figure 8 and Figure 9), providing evidence of salmonids using the fish passes and running the river to access spawning habitat in the Trent catchment.

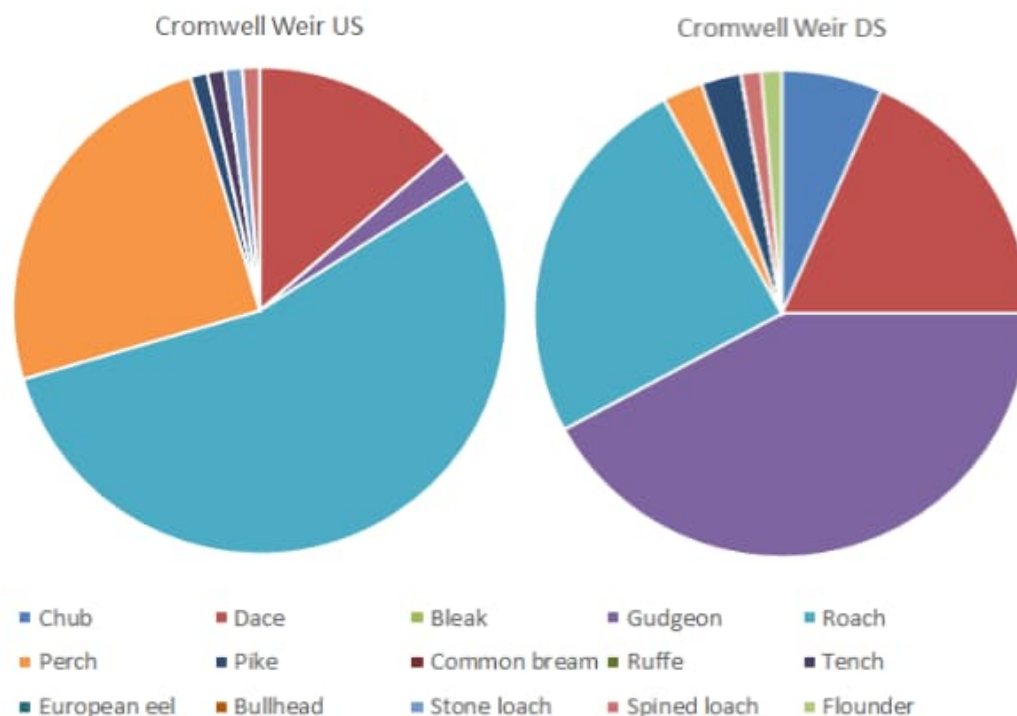
**Figure 10: Catch compositions upstream and downstream of Cromwell Weir**

- 3.5.6 Cromwell Weir was surveyed on the 6 August 2021. The average river width was 80 m and the depth was estimated to be >2 m. The weather was wet and overcast.
- 3.5.7 A 200 m section of the right bank and 340 m of the left bank were surveyed for fish upstream of the weir. Eight fish species were caught and a total of 86 individuals. Roach, dace and perch were the most numerous species caught. European eels were also seen by the surveyors but not captured. Spined loach was the only notable species caught (Figure 10; Table 11).
- 3.5.8 Downstream of the weir a 215 m run was undertaken on the left bank. No surveying was completed on the right bank due to a large number of anglers throughout this stretch. Eight fish species were captured totalling 74 individuals. Gudgeon, roach and dace were the dominant species. Spined loach was the only notable species caught (Figure 10; Table 11).

- 3.5.9 The upstream and downstream catches varied in species abundance with gudgeon becoming more dominant downstream. Gudgeon are a benthic species and shallower water depths sampled downstream in the marginal areas would have meant more suitable habitat was present for these species. Perch were far more abundant upstream and again this could be due to more preferable submerged macrophyte coverage and lower flows upstream compared to downstream. A single flounder was caught downstream of Cromwell indicating the tidal limit of the Trent.

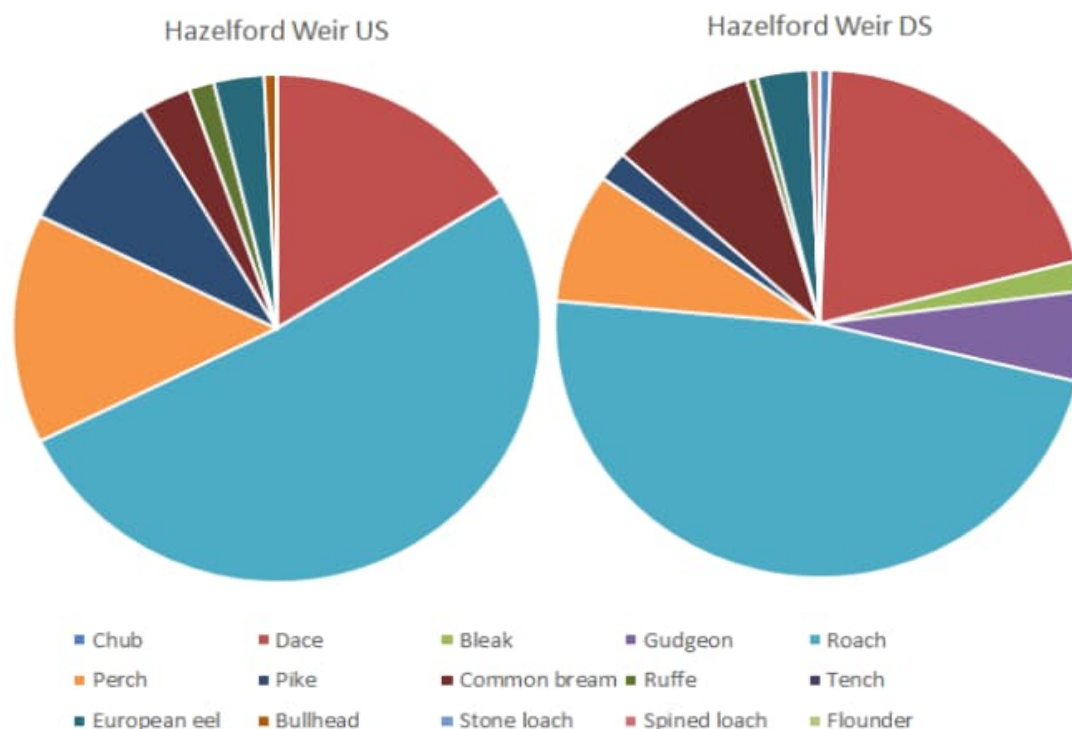
Figure 11: Catch compositions upstream and downstream of Hazelford Weir

- 3.5.12 Downstream of Hazelford weir, a 340 m run of the left bank was surveyed; none of the right bank was surveyed due to a large section of concrete piling and lack of habitat. A total of 11 species were caught totalling 157 individuals. Notable species included five eel and one spined loach (Figure 11; Table 11).

- 3.5.13 Roach and dace dominated the catch both up and downstream. Eel were equally caught both above and below the weir indicating passage is available for these migratory species. Pike were much more abundant upstream of the weir indicating that the suitability of habitat was greater upstream with submerged macrophytes and lower flows.

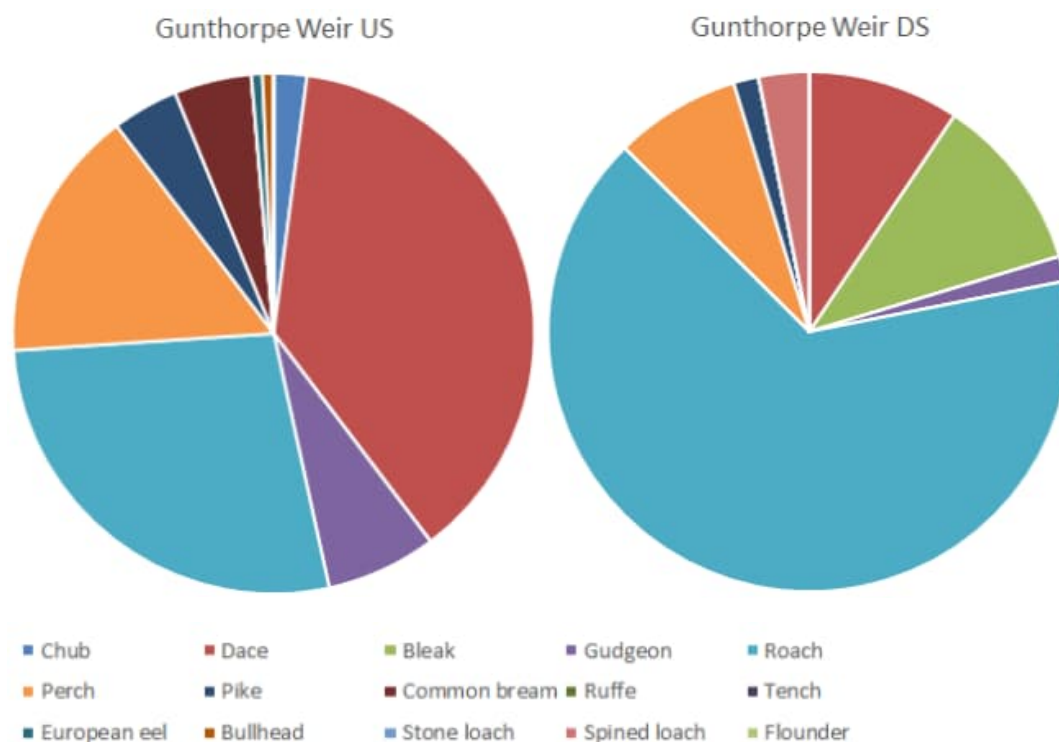
Figure 12: Catch compositions upstream and downstream of Gunthorpe Weir

- 3.5.16 Downstream of Gunthorpe weir a 350 m section of the right bank was surveyed. The left bank was not surveyed due to a lack of suitable habitat and the presence of anglers. 64 individuals were caught from seven different species. Roach dominated the catch downstream. Notable species caught included spined loach (Figure 12; Table 11).

- 3.5.17 The section surveyed upstream was of a far greater area than downstream due to habitat and access suitability. This is shown in the lower numbers of fish caught downstream of the weir.

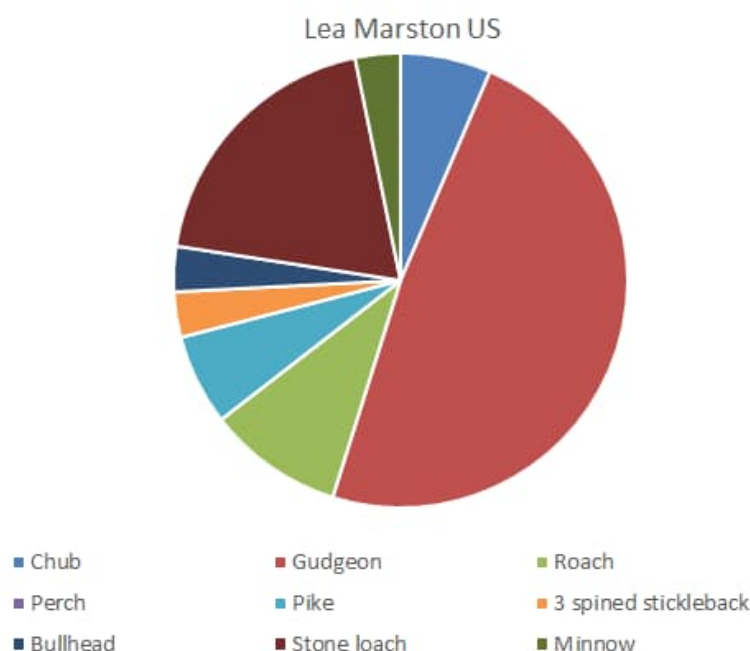
Figure 13: Catch compositions upstream of Lea Marston Weir

3.5.21 A 560 m section of the river was fished. 31 individuals were caught from 8 different species with gudgeon dominating the catch. Notable species caught were bullhead (Figure 13; Table 12).
